FAILURE OF TETON DAM

A REPORT OF FINDINGS

by
U.S. DEPARTMENT OF THE INTERIOR
TETON DAM FAILURE REVIEW GROUP
April 1977

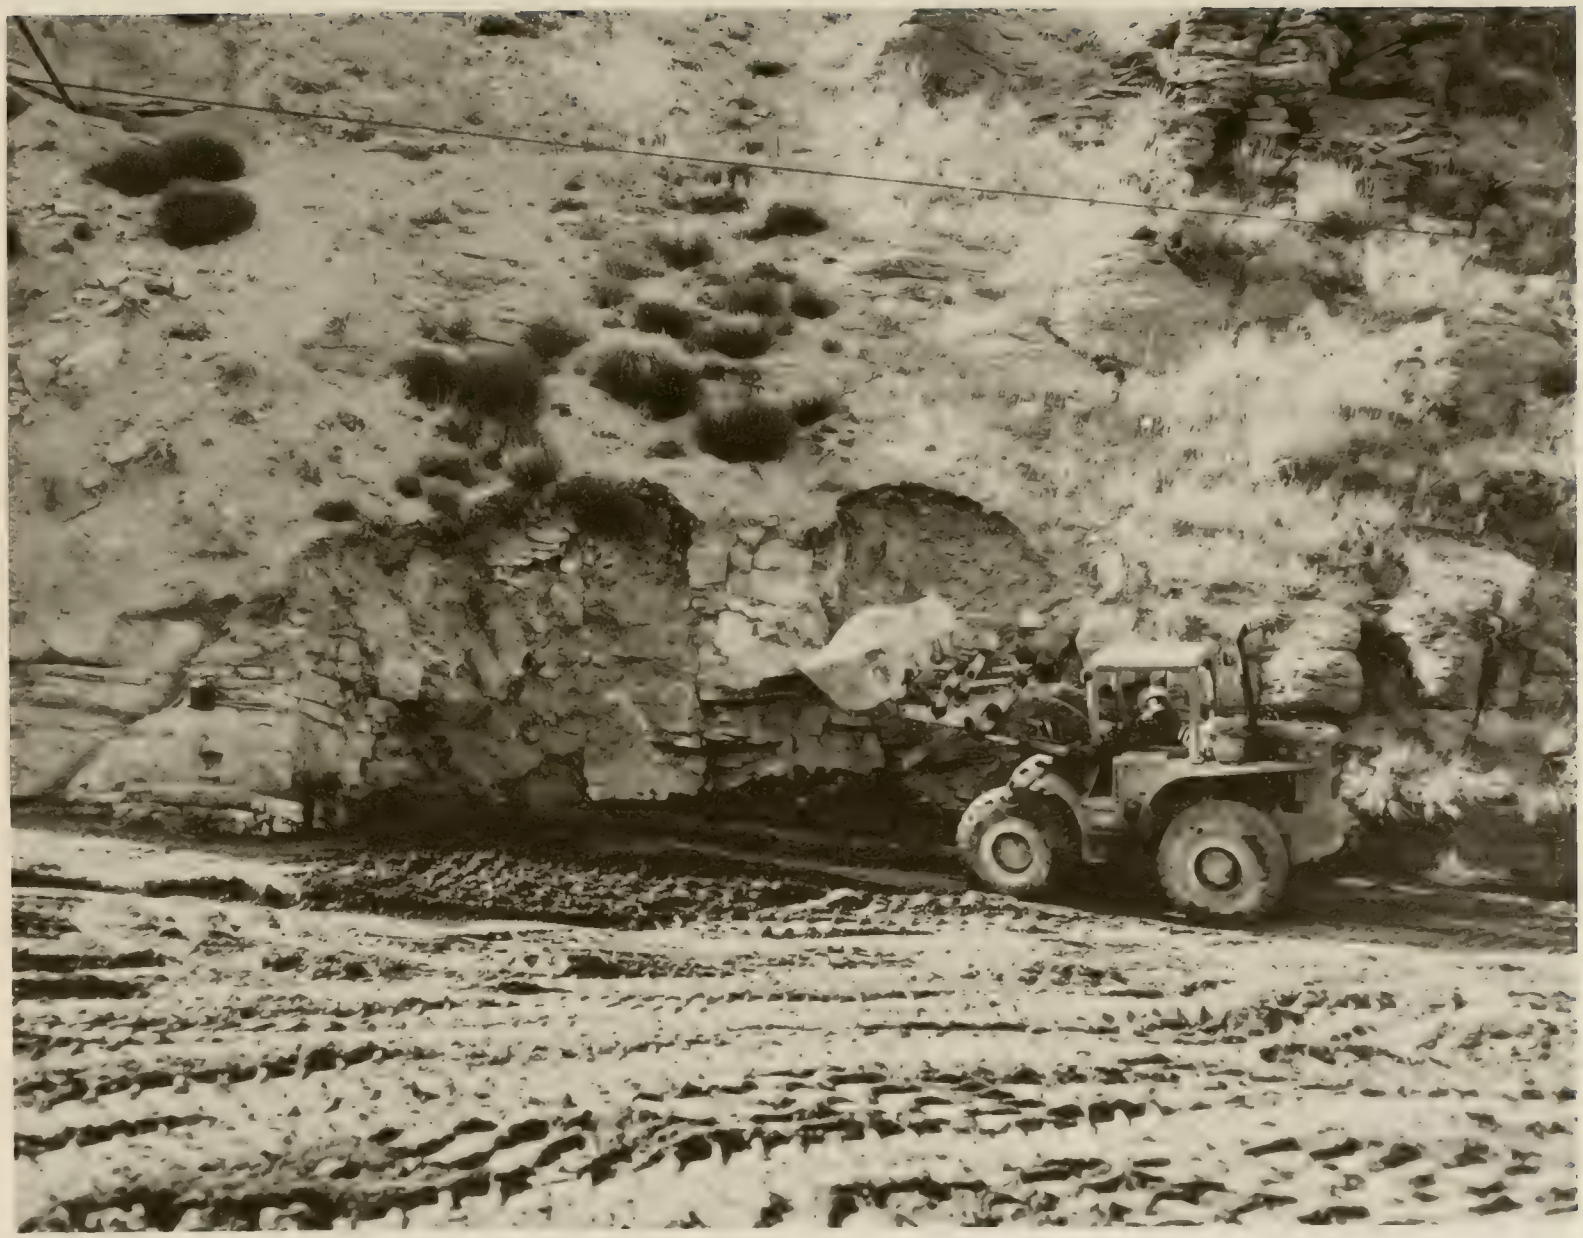
12.—Hydraulic hammer used for special compactor along abutment and around tower supports, 7/2/74; P549-147-4590 NA.

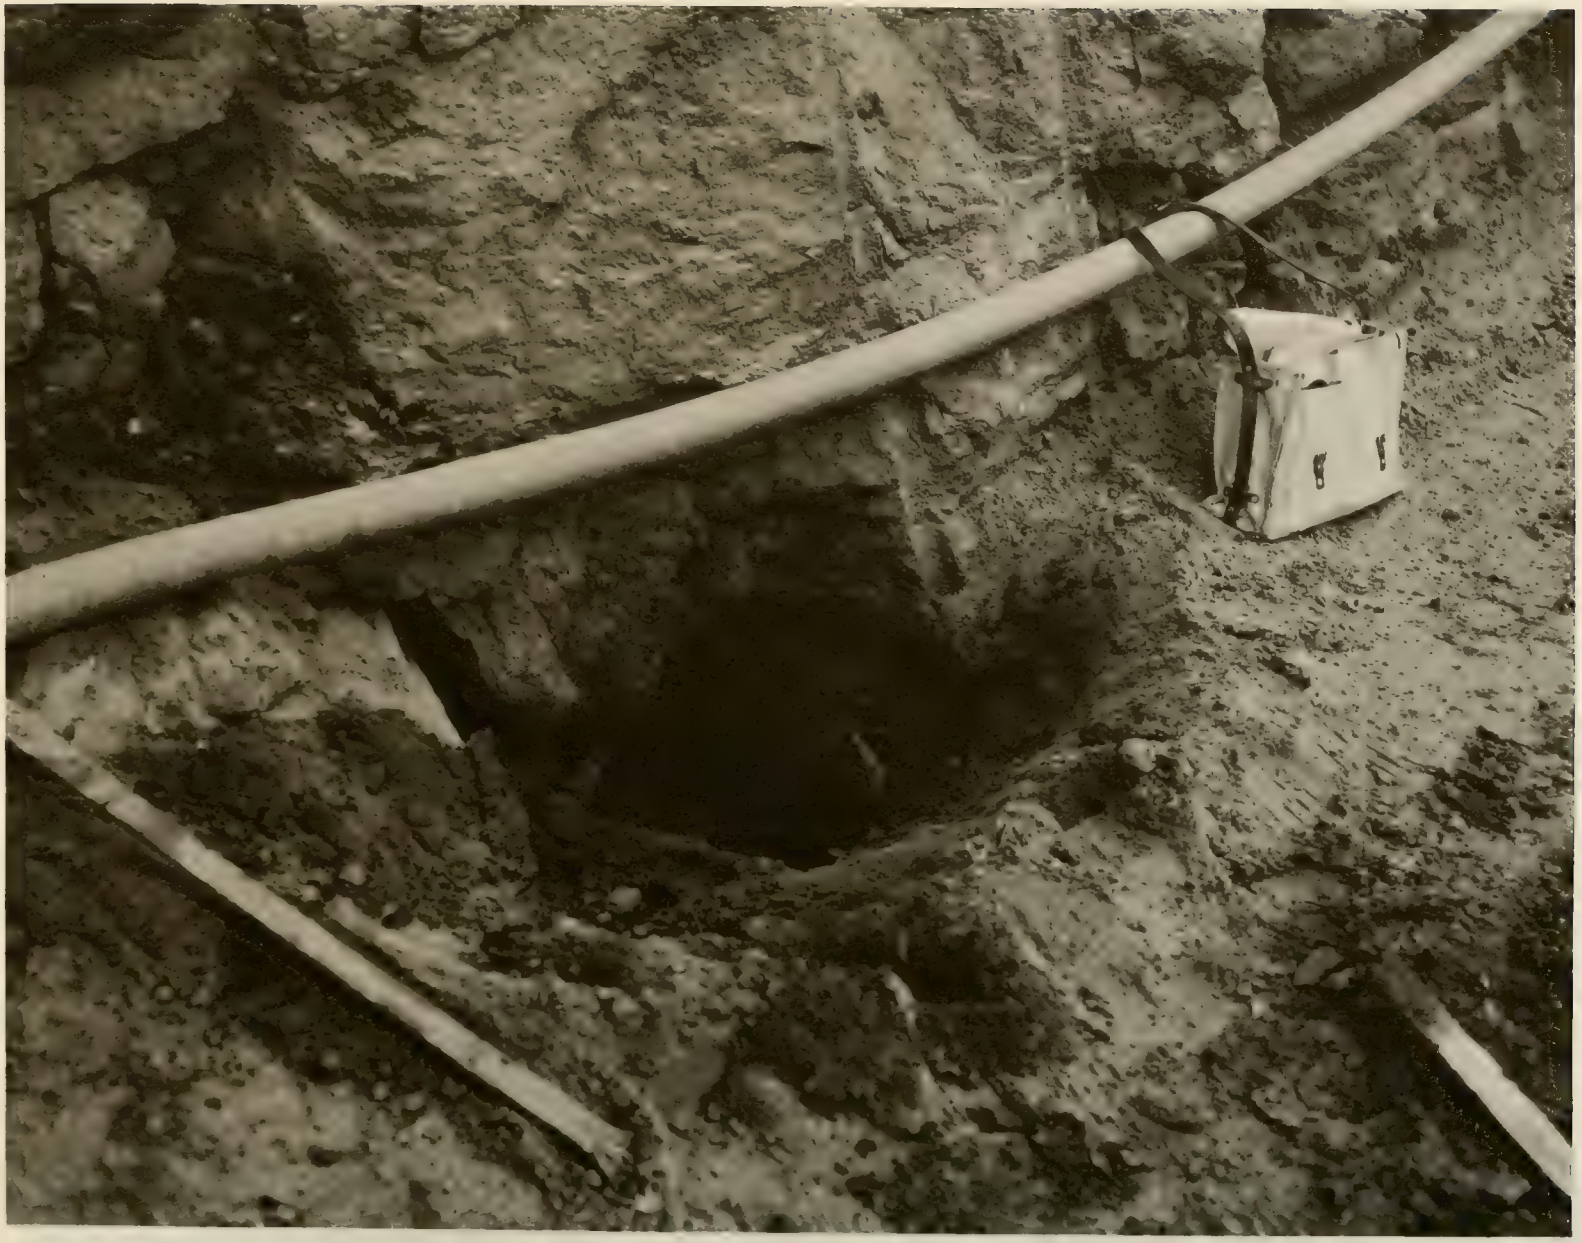
13.—Right abutment showing rock 260 to 300 feet upstream of centerline. Zone 1 embankment elevation is 5106, 10/11/74; P549-147-5044 NA.

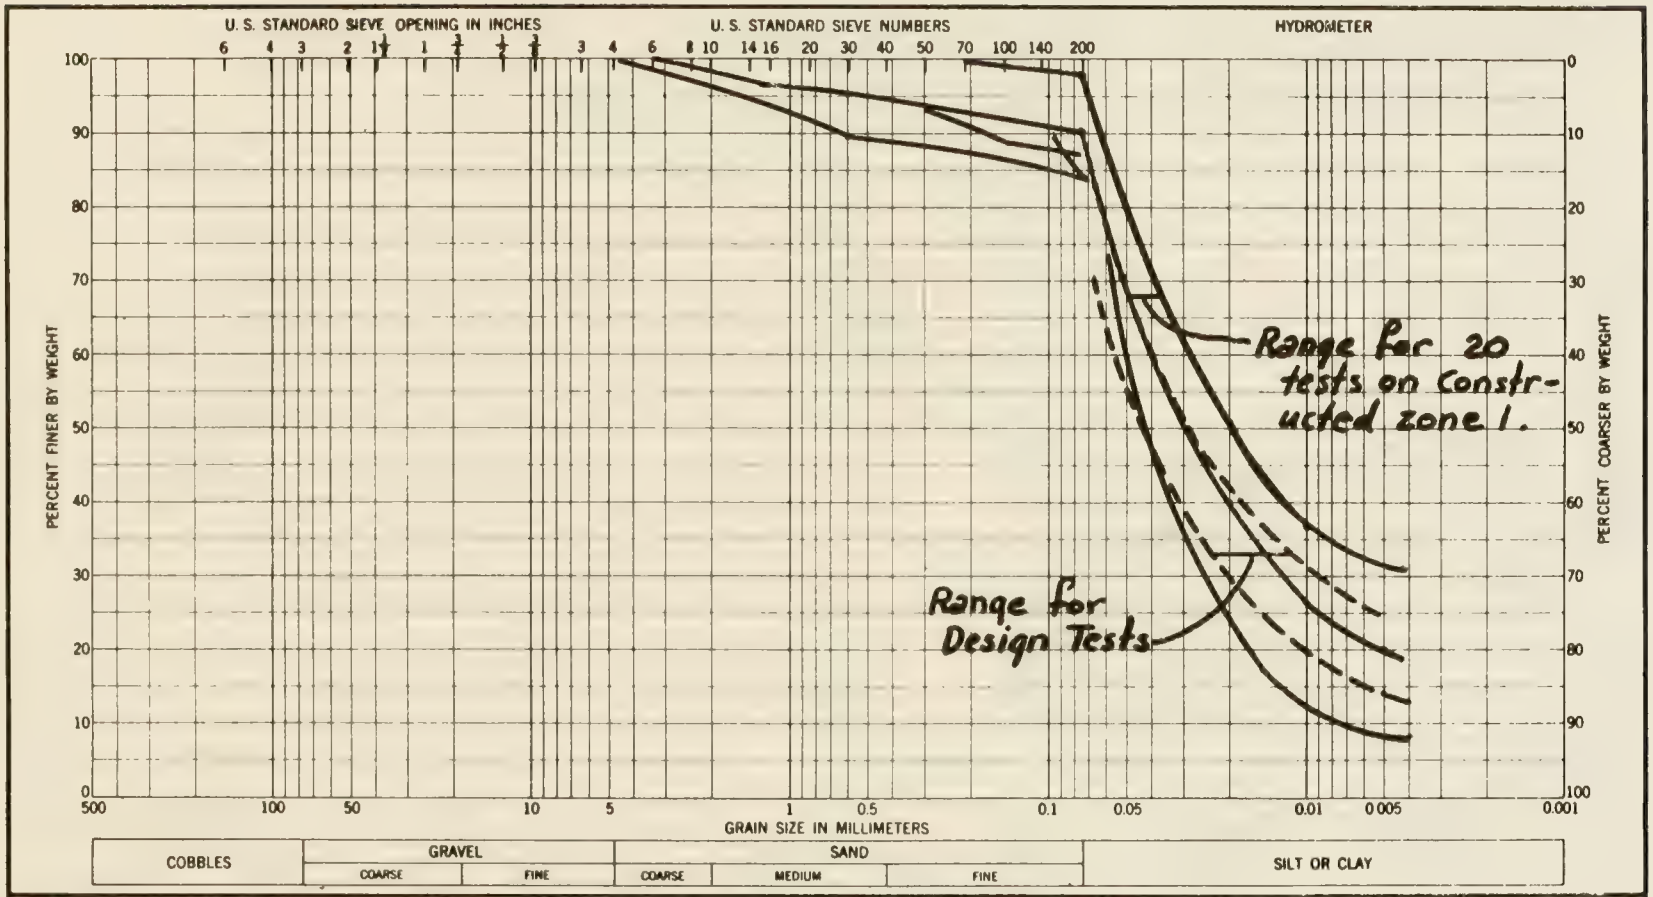
Figure D5-2

Range of Gradation
Zone 1 Material

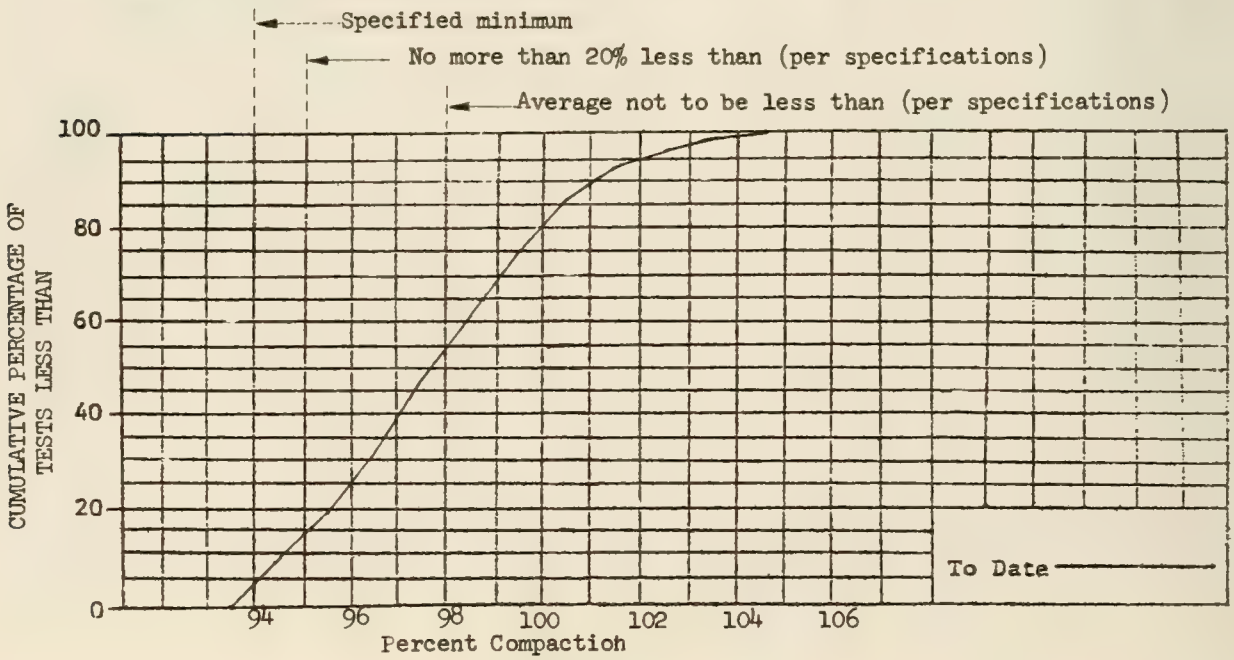
Figure D5-4

Prev.	This Period	To Date
Avg. fill dry density, γ_{df}, pcf			99.1
Avg. maximum dry density, γ_{dL}, pcf (Lab.)			100.8
Mean percentage of lab. max. dry density			98.3

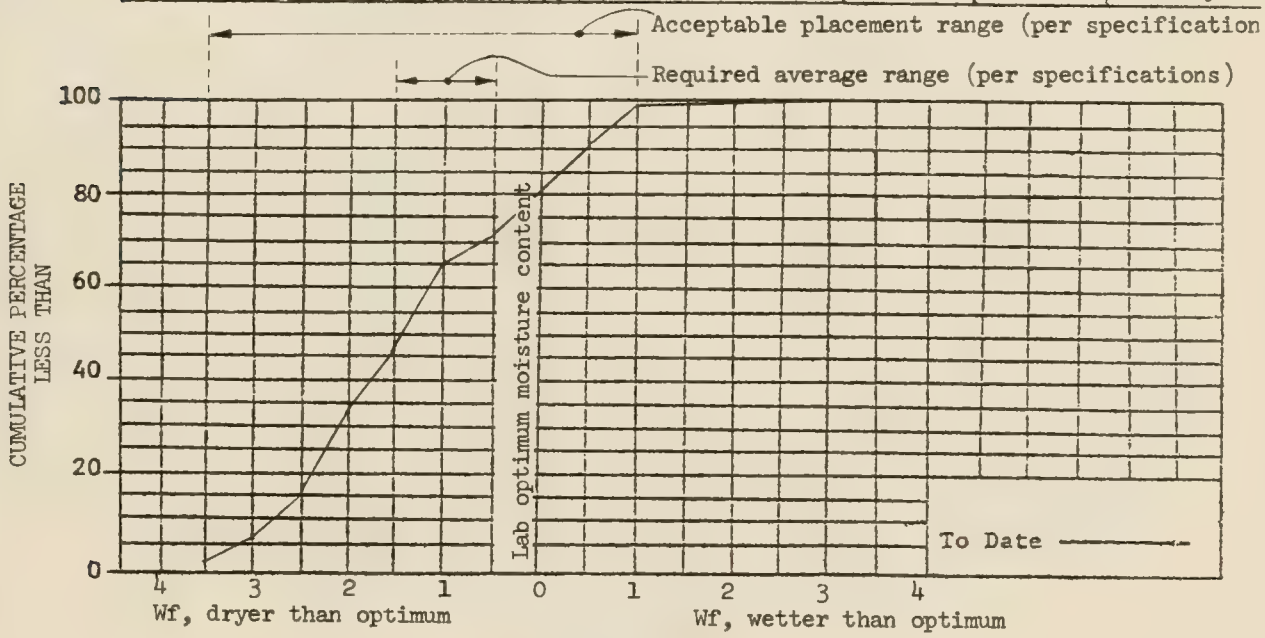
Figure D5-5

Prev.	This Period	To Date
Avg. fill moisture content, W_f, %			18.5
Avg. optimum moisture content, W_o, %			19.6
Mean variation from optimum moisture content			1.1 Dry

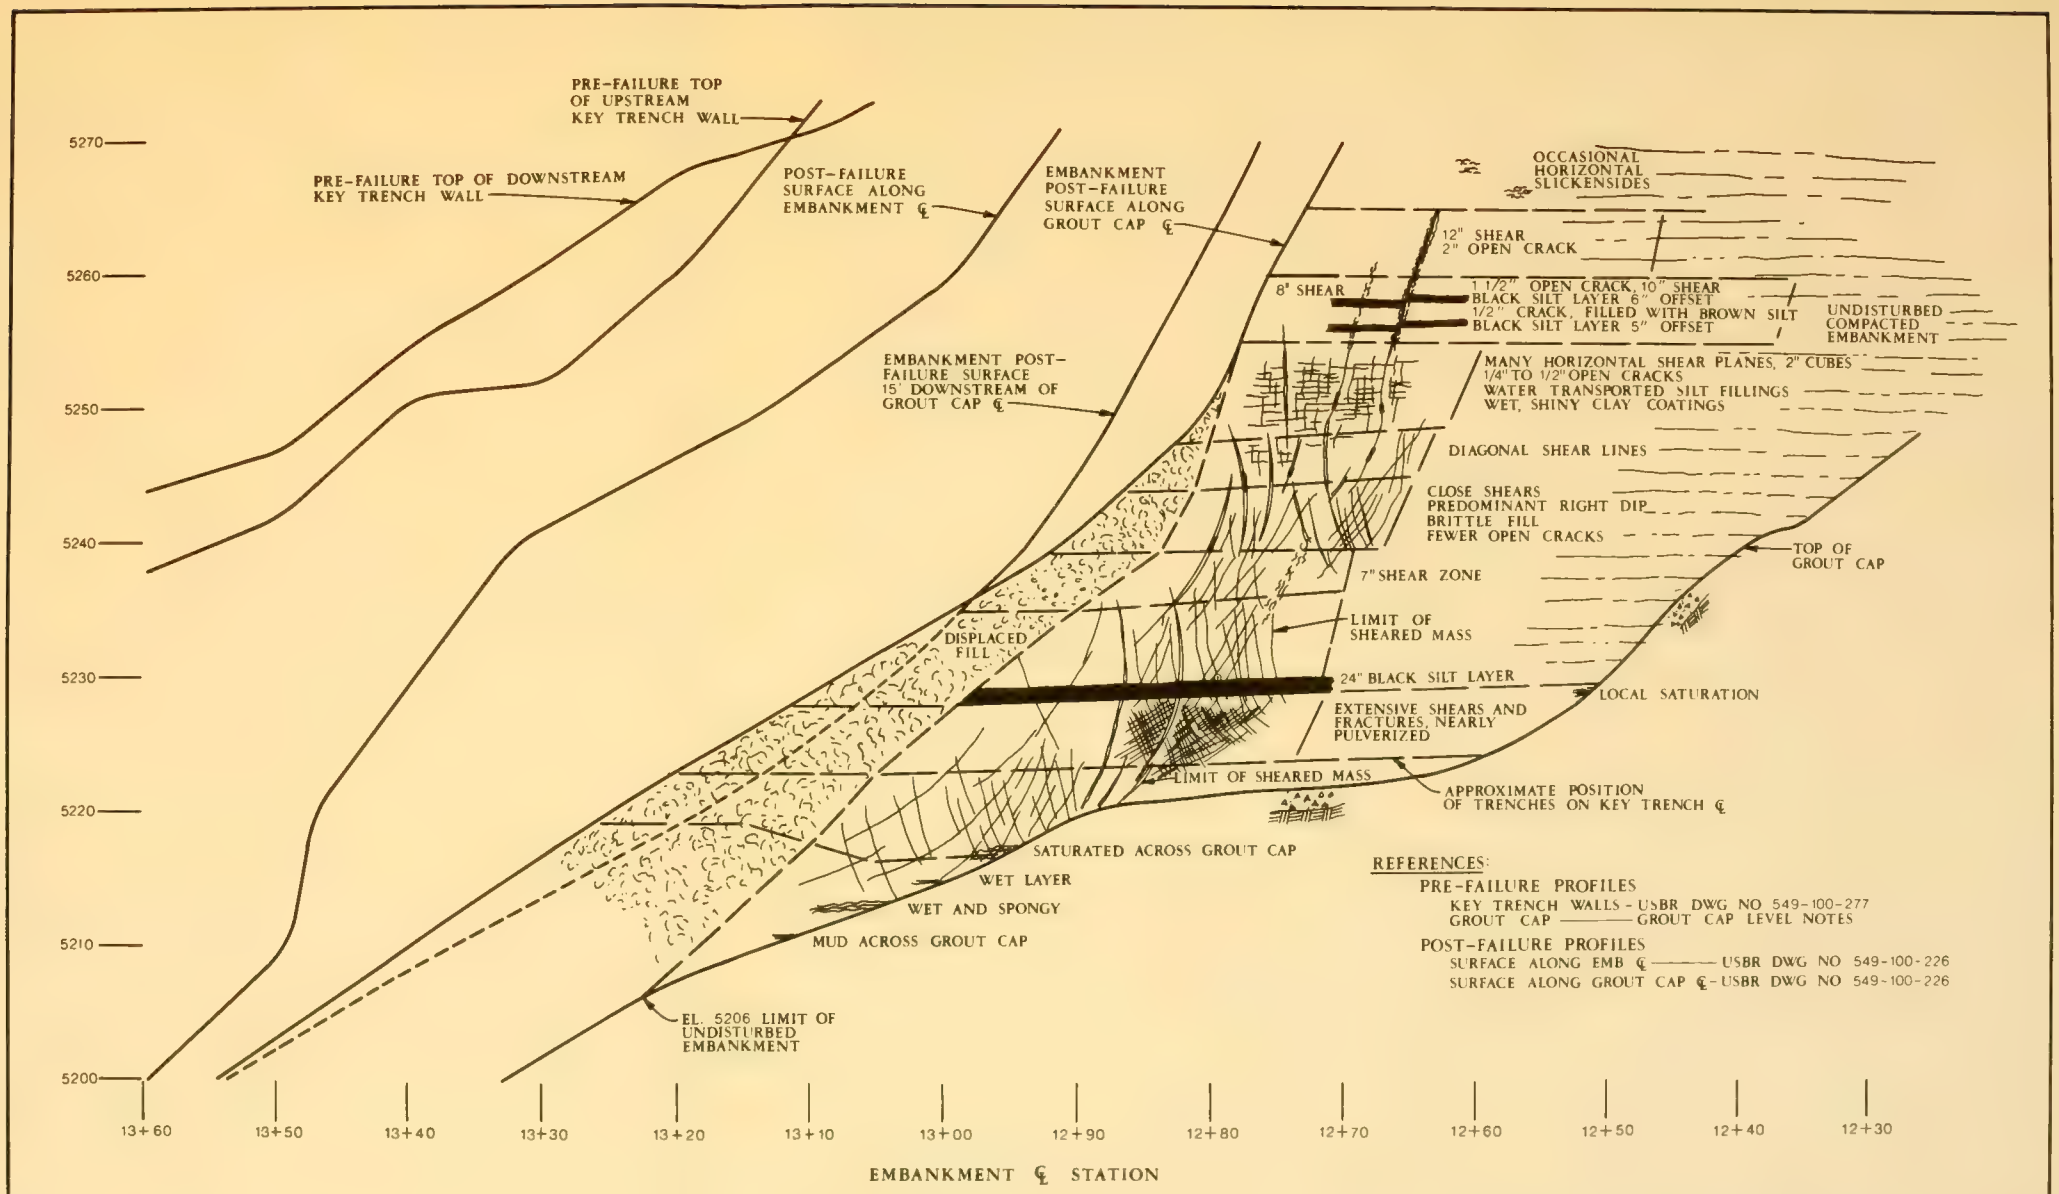
FIG. 3-5. U S DEPARTMENT OF THE INTERIOR — STATE OF IDAHO INDEPENDENT PANEL TO REVIEW CAUSE OF TETON DAM FAILURE

Undisturbed, hand-cut block samples, 9 in. x 9 in. x 9 in. in dimension, and 3 in. x 36 in. Shelby tube drive samples together with 10-lb bag samples taken nearby were obtained at the locations shown in Fig. 3-5.

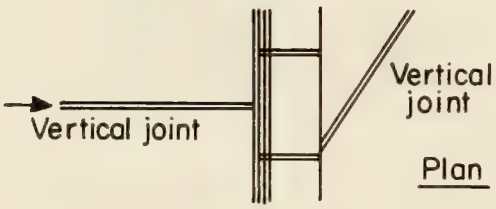
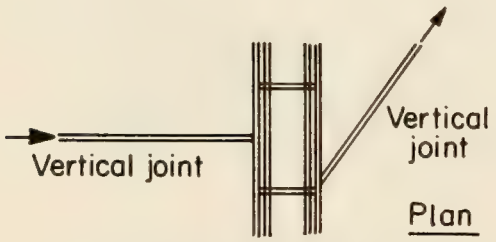
FIG. 1 SCHEMATIC DIAGRAMS SHOWING DEVELOPMENT OF HYDRAULIC FRACTURING AND FLOW OF WATER THROUGH KEY TRENCHES

The general hypothesis whereby failure could have occurred as a result of internal erosion due to leakage through cracks in the key-trench fill caused by hydraulic fracturing is illustrated schematically in Fig. 1. If the grout curtain were fully or highly effective, the highly pervious nature of the upstream rock along vertical and horizontal joints would lead to a condition of essentially full hydrostatic pressures developing along some zones of the upstream face of the key trench. Even if the cutoff allowed some seepage under the key trench, high water pressures might still develop against the upstream face of the key-trench fill. As shown in Fig. 1, step 1, these pressures could cause fracturing of the fill where it came in contact with the joints. The resulting cracks would tend to be along the minor principal planes and would propagate longitudinally along the wall of the trench, permitting water to have access to the wall over a considerable length of the key trench.

In a coincident or second step (step 2 in Fig. 1) the water pressures thus developed would tend to produce multiple fractures along transverse planes with low normal stresses acting on them due to the arching action of the fill over the soil in the key trench. This would provide access for the water to the downstream face of the key trench.

Once this stage was reached, further fracturing could occur along minor principal planes for soil elements adjacent to the downstream wall of the key trench, again permitting the water to flow longitudinally until it found a convenient egress through open joints in the downstream rock. Erosion along the resulting flow path would ultimately lead to a piping failure of the embankment as discussed in a later section.

1. Flow in vertical upstream joint to face of key trench followed by longitudinal hydraulic fracturing of fill near face of trench allowing water to spread along face

2. Transverse hydraulic fracturing producing multiple fractures through soil in key trench and giving water access to downstream side of trench (may occur before Step 1)

3. Longitudinal hydraulic fracturing of soil near downstream face of key trench allowing water to spread along face and find egress through open downstream joints in rock

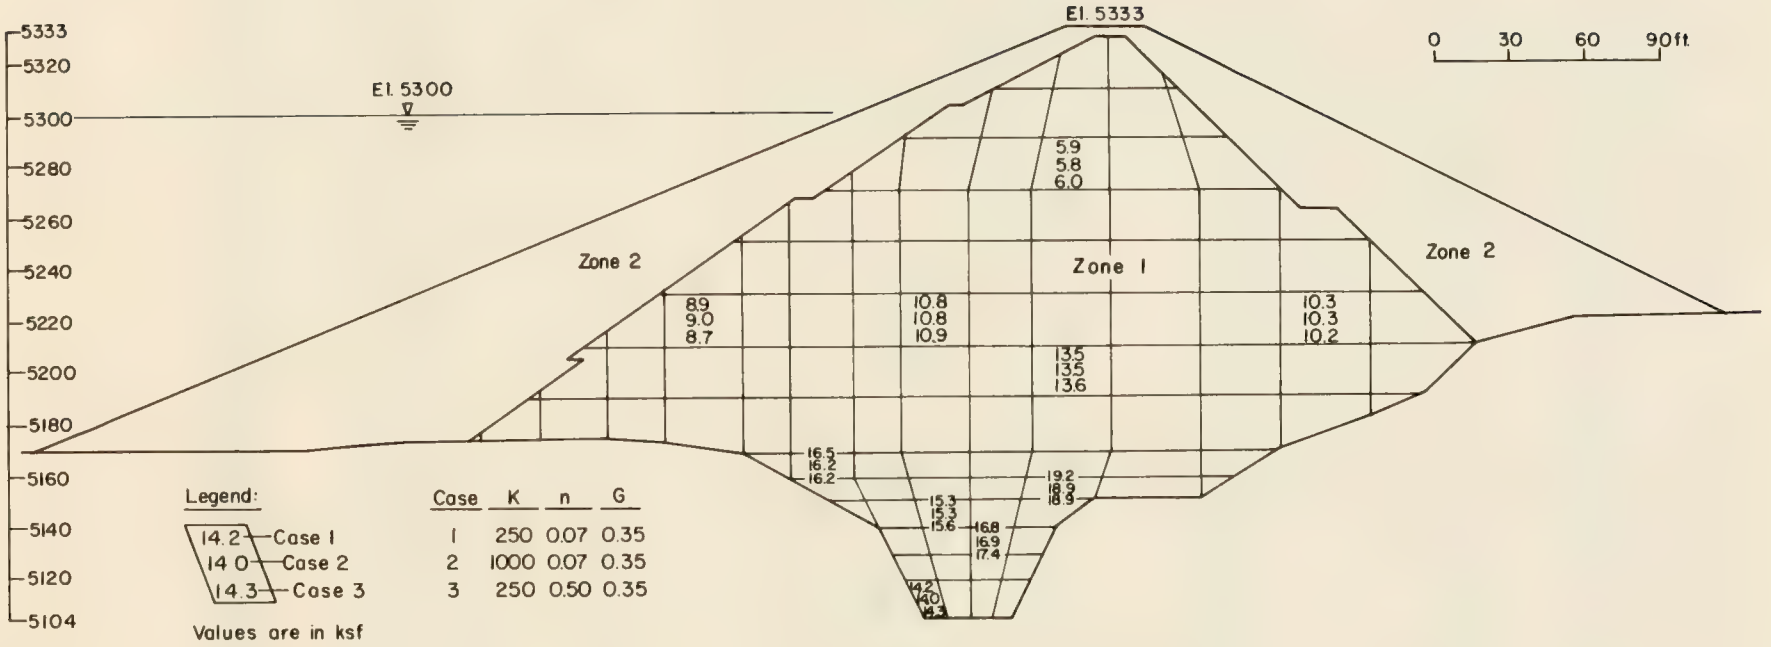
FIG. 2 EFFECT OF VARIATIONS IN PARAMETERS K AND n ON COMPUTED VALUES OF MAJOR PRINCIPAL STRESS AT STA. 15+00

Other parameters were maintained constant at their most likely values (e.g. G = 0.35; γ = 117 lb/ft^3; c = 1650 psf, ϕ= 31^o; etc.). The results of these studies are shown in Figs. 2 and 3. Fig. 2 shows computed values of the major principal stress and Fig. 3 shows computed values of the minor principal stress at a number of representative points both in the key trench and throughout the Zone 1 fill. It may be seen that, in spite of the wide variations in K and n, the values of the computed stresses do not change appreciably, indicating that the stress analysis procedure is insensitive to reasonable variations in these parameters. In view of this it was considered appropriate to use representative values, based on the test data and on experience with determinations of parameters for other soils. On this basis, the following parameters were selected for use in all further analyses:

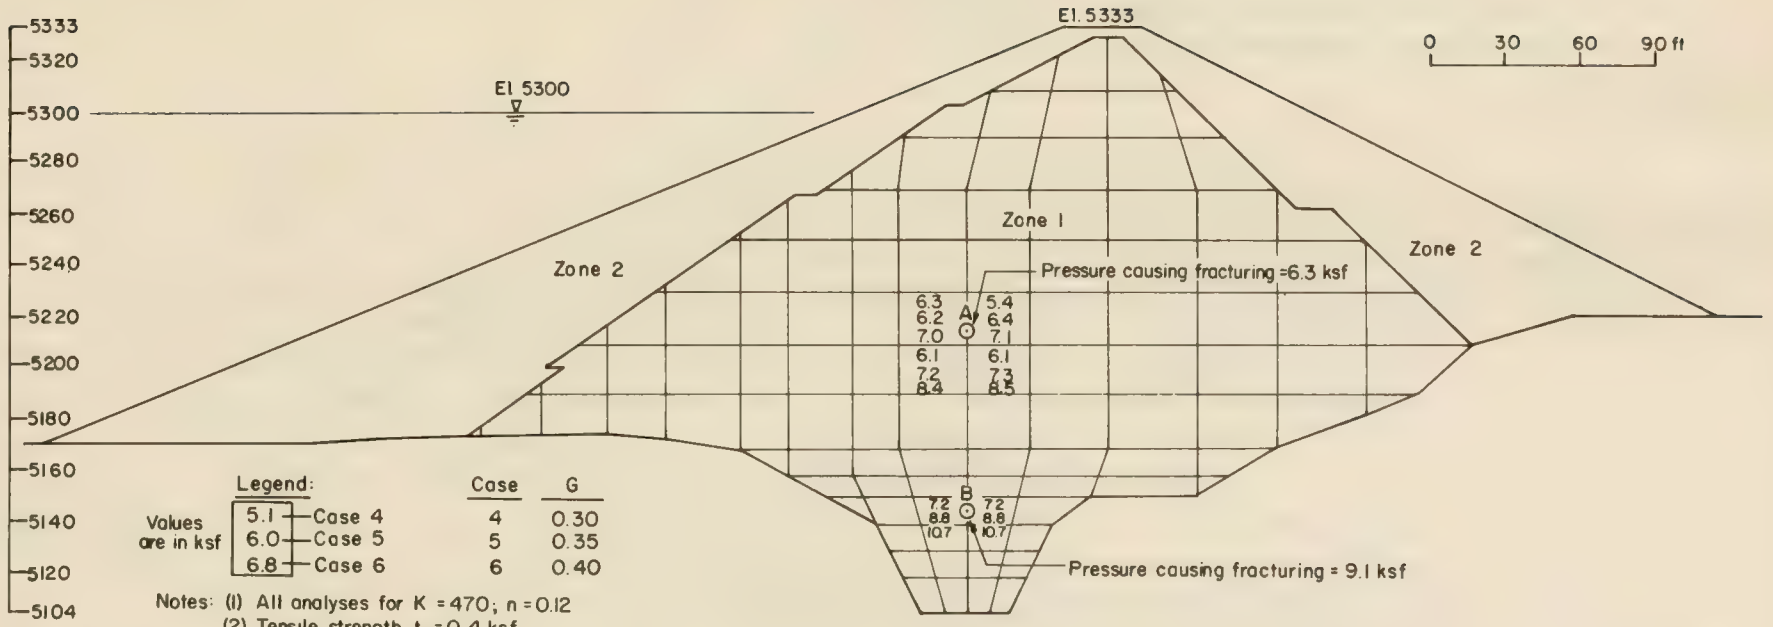
FIG. 4 EFFECT OF VARIATIONS IN PARAMETER G ON COMPUTED VALUES OF SUM OF MINOR PRINCIPAL STRESS AND TENSILE STRENGTH OF SOIL - STA. 15+00 KEY TRENCH ASSUMED TO BE UNWETTED

The first test was performed at Station 26+00 where fracturing was induced at El. 5210 under a water head of 101 ft, corresponding to a pressure of 6.3 ksf. The location of the test, superimposed on the cross-section at Station 15+00, is shown by point A in Figs. 4 and 5. Also shown in the figures are the computed stress conditions required to cause hydraulic fracturing in the vicinity of A for three different values of the parameter G and for the case where the key-trench fill is assumed to be unwetted (Fig. 4) and wetted (Fig. 5). It was estimated that the tensile strength of the Zone 1 fill was about 0.4 ksf for this purpose. It will be seen that, in Fig. 4 the computed stress required to induce fracturing at point A is about 6.5 ksf for G = 0.35, while in Fig. 5, the computed fracturing pressure is about 6.3 ksf for G = 0.35. Both of these computed results are in excellent agreement with the measured pressure causing fracturing in the field, but results for other values of G are significantly less favorable.

The third test was performed at Sta. 27+00 in a hole drilled to El. 5190. The hole was then filled with water to El. 5315 but no evidence of hydraulic fracturing was observed. The pressure at the bottom of the hole under this head was 7.8 ksf. The location of this test point superimposed on the cross-section at Station 13+70 is shown in Fig. 6. It may be noted that for G = 0.35, the corresponding value of the computed pressure required to cause hydraulic fracturing at this location is only 6.4 ksf. It seems likely, based on the results shown in Figs. 5 and 6, that a computed pressure in good agreement with the field test result might have been obtained if the analysis had been made for G = 0.4.

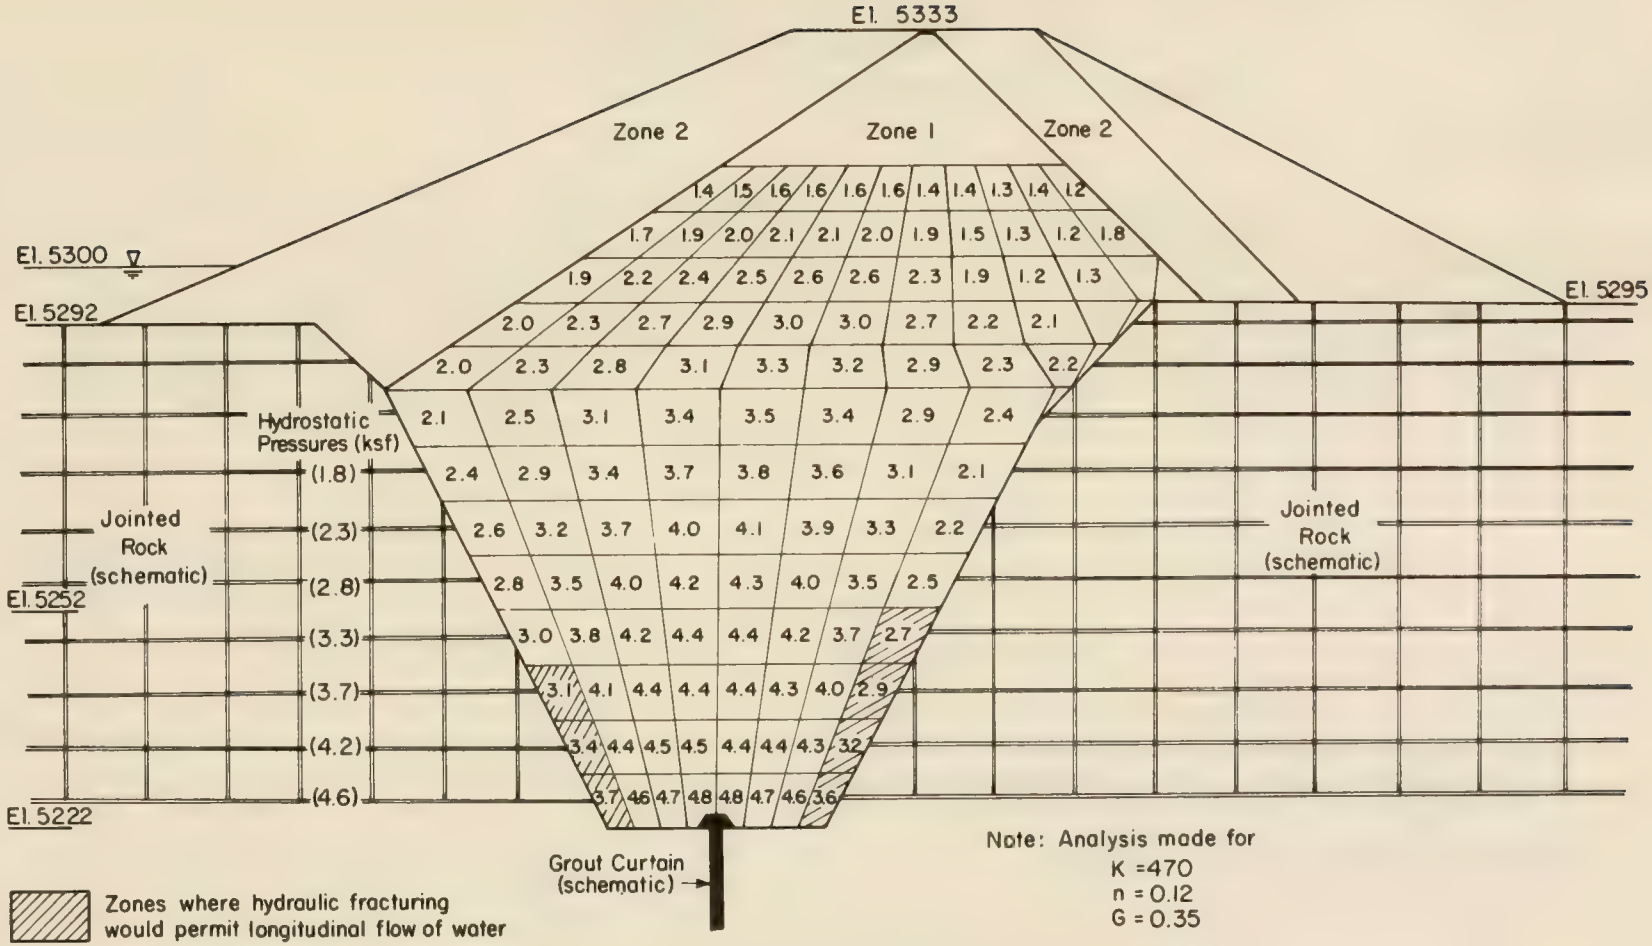
FIG. 7 COMPUTED VALUES OF MINOR PRINCIPAL STRESS IN PLANE OF SECTION ksf STA. 12+70

An idealized cross-section through the embankment at Sta. 12+70 is shown in Fig. 7. Before discussing the computed values of stresses developed throughout the embankment it is useful to note the stress conditions in a soil element adjacent to the upstream face of the key trench. Such an element is shown in Fig. 8 together with the orientations of the major and minor principal stresses. Since hydraulic fracturing is likely to occur first on the plane with the lowest value of normal stress it will always tend to be initiated on the minor principal plane, which for the element shown is inclined inwards at about 30^{o} to the vertical. On the centerline of the trench the minor principal plane will be essentially vertical while on the downstream side of the face of the trench it will be inclined at the opposite direction to that shown in Fig. 8. Whether or not fracturing will occur on such planes depends on the relative values of the water pressure on the face of the trench and the minor principal stresses in soil elements adjacent to the wall of the trench.

A comparison of these stresses is shown in Fig. 7. Values of the minor principal stress developed in different elements of the finite element mesh are shown directly in the elements in ksf units and the hydrostatic water pressures assumed to develop in a highly jointed rock for a reservoir level of 5300 (the elevation at the time the dam failed) are shown adjacent to the elements in parentheses. It may be seen that for this section hydraulic fracturing of the type described above is only indicated for the outer rows of elements in the bottom part of the trench (shown shaded) and elements on the downstream side would only fracture if full hydrostatic pressure could develop in this area. In these elements and zones, however, the analyses would indicate the onset of hydraulic fracturing which could be expected to propagate from any point of initiation in a longitudinal direction, providing the possibility of full hydrostatic pressures developing over a substantial area near the lower part of the upstream face of the key trench. The resulting fractures are illustrated schematically in Fig. 9.

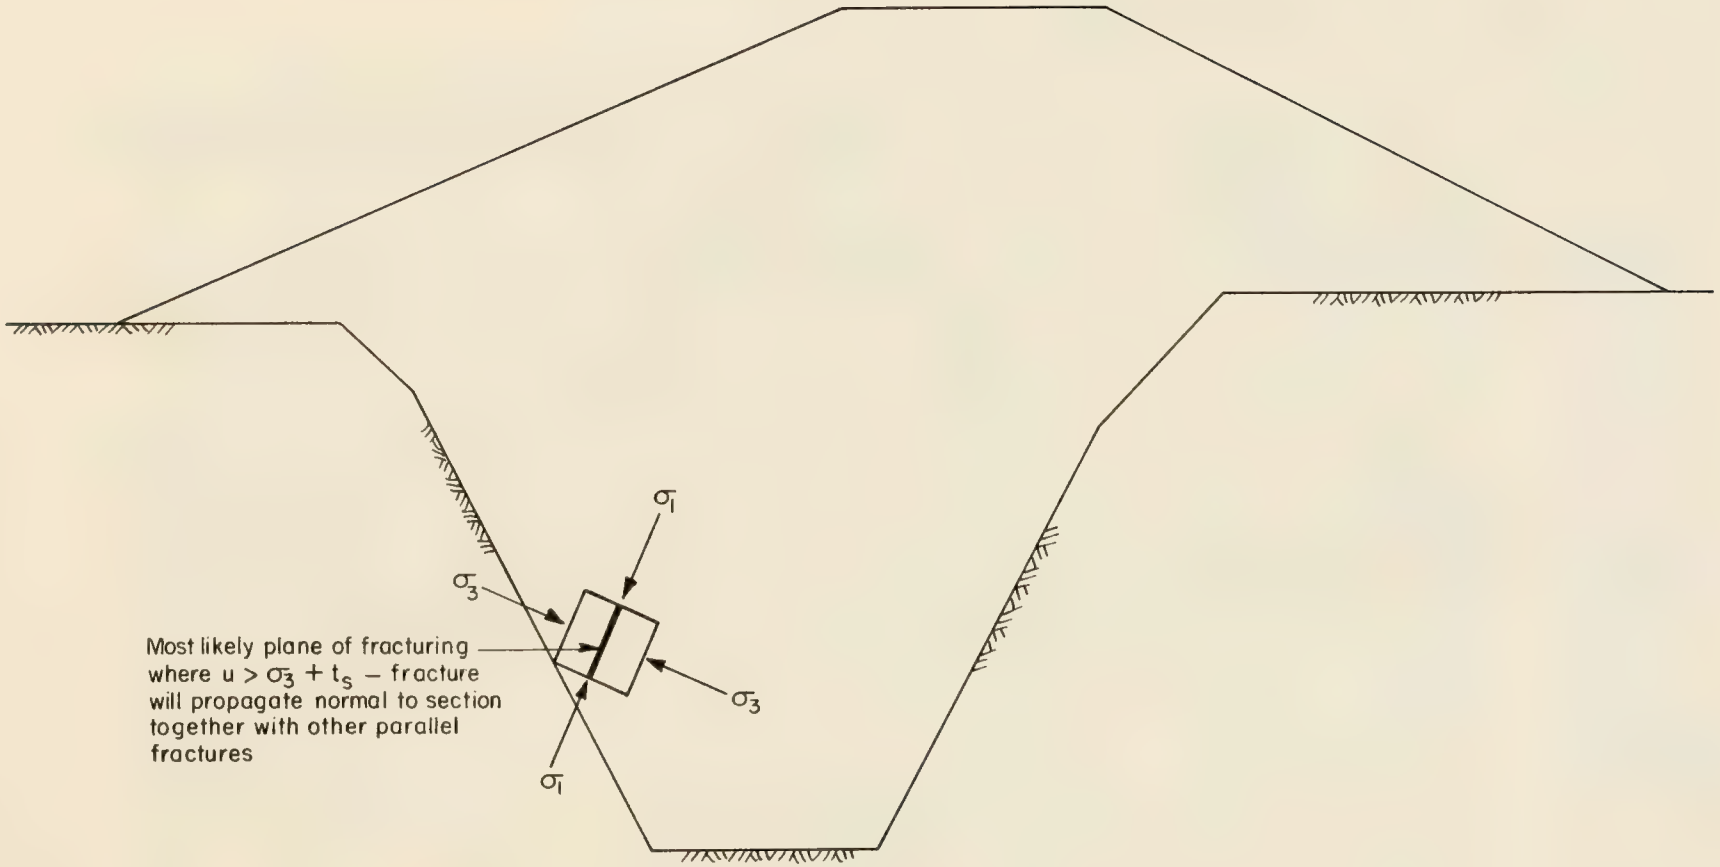
FIG. 8 DEVELOPMENT OF LONGITUDINAL FRACTURE PATTERN

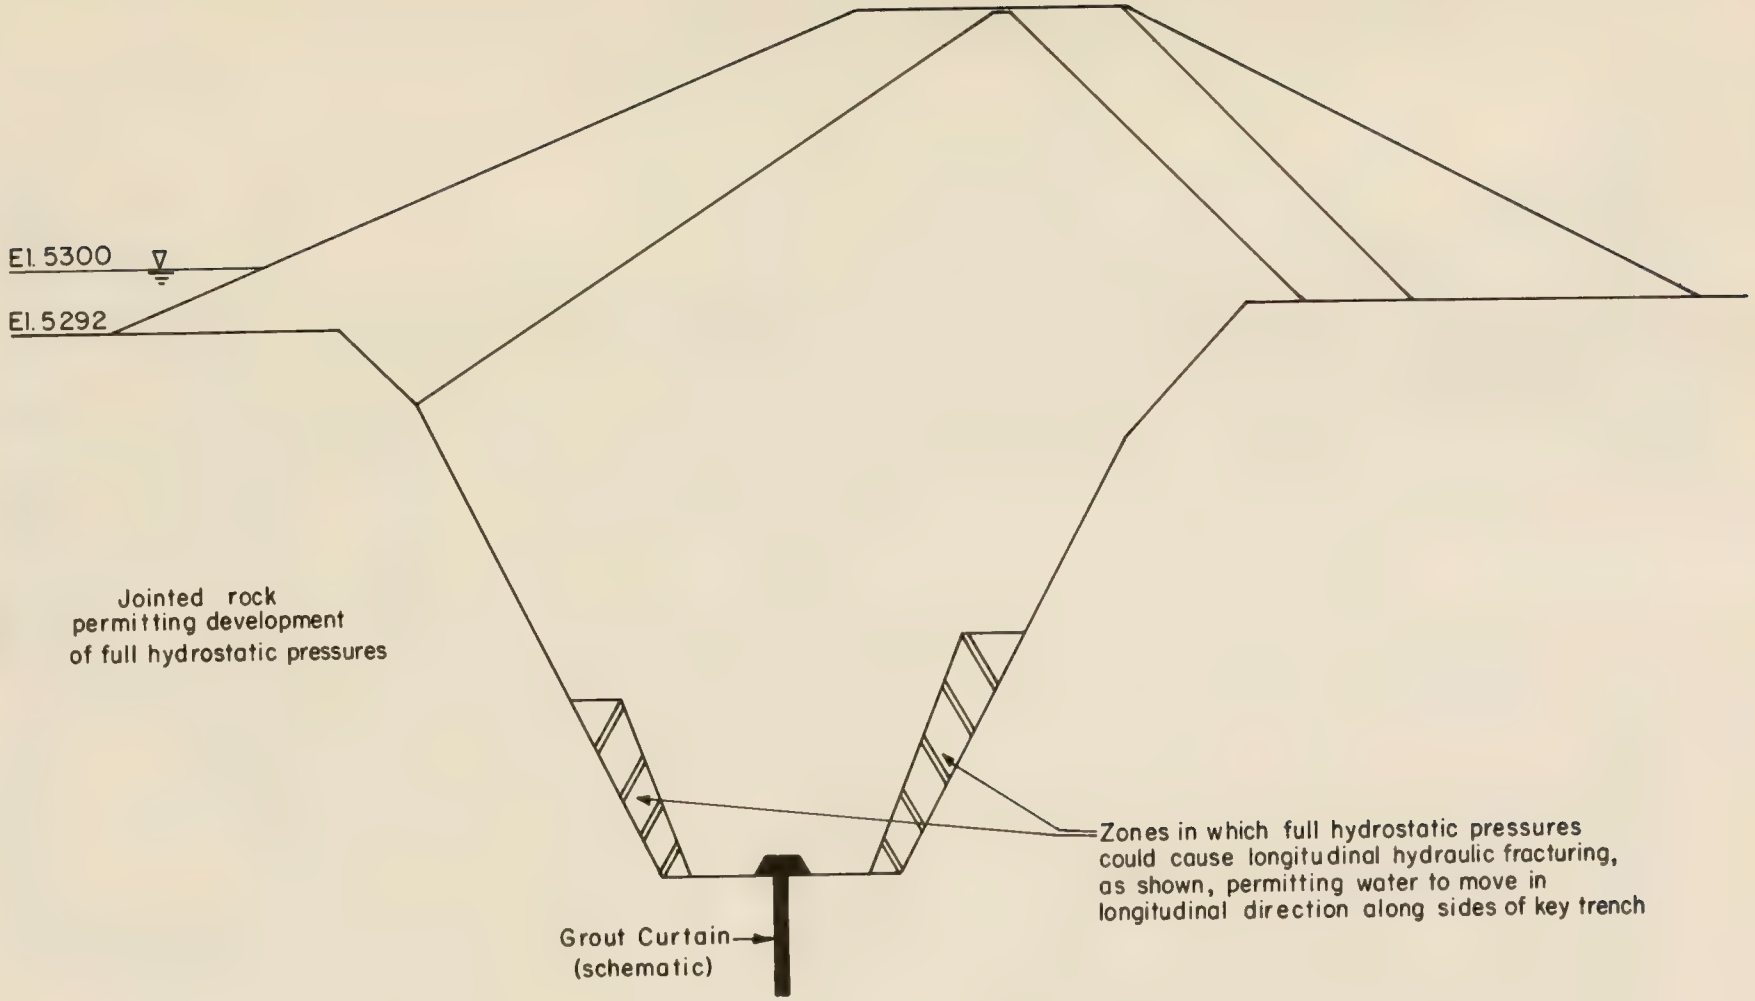
FIG. 9 ZONES OF POTENTIAL LONGITUDINAL FRACTURING AT STA. 12 + 70

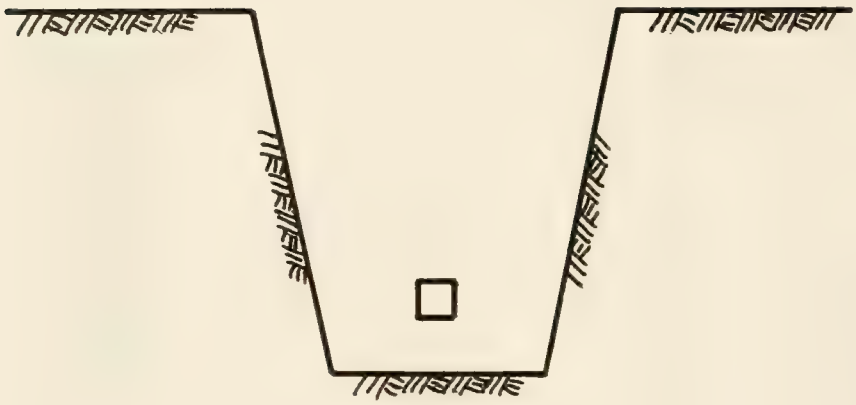
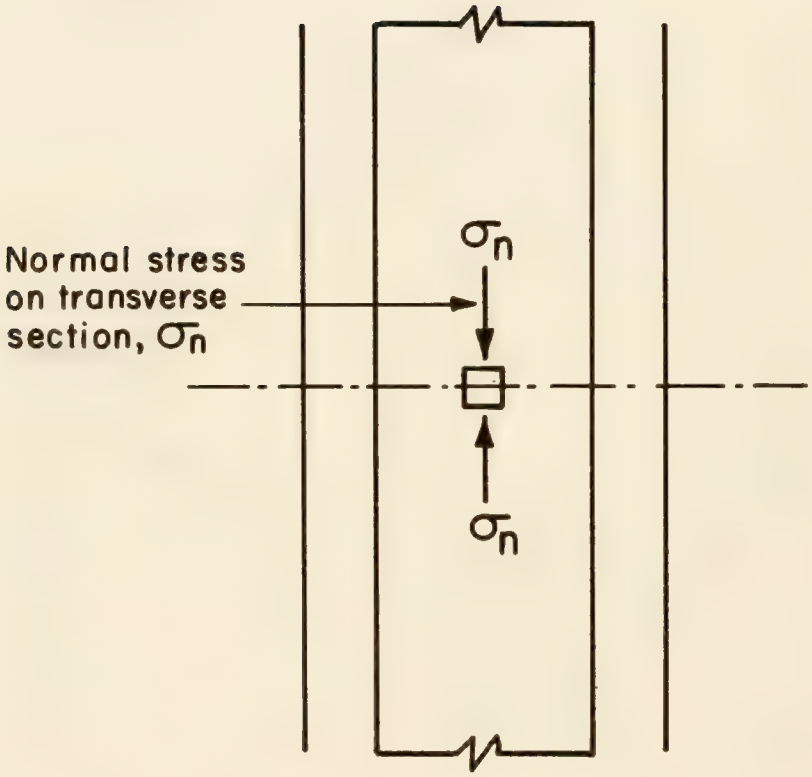
FIG. 10 MECHANISM FOR TRANSVERSE FRACTURING IN KEY TRENCH

With regard to the possibility of hydraulic fracturing in the transverse direction it is necessary to compare the hydrostatic water pressures with the sum of the normal stress on the transverse section and the tensile strength of the soil as illustrated in Fig. 10. A comparison of the computed normal stress on the transverse plane with the full hydrostatic pressures is shown in Fig. 11. It may be seen that the analysis indicates that the stresses developed at all elevations in this section would be sufficient to preclude the possibility of transverse fracturing.

Transverse fracturing occurs if $u > \sigma_n + t_s$

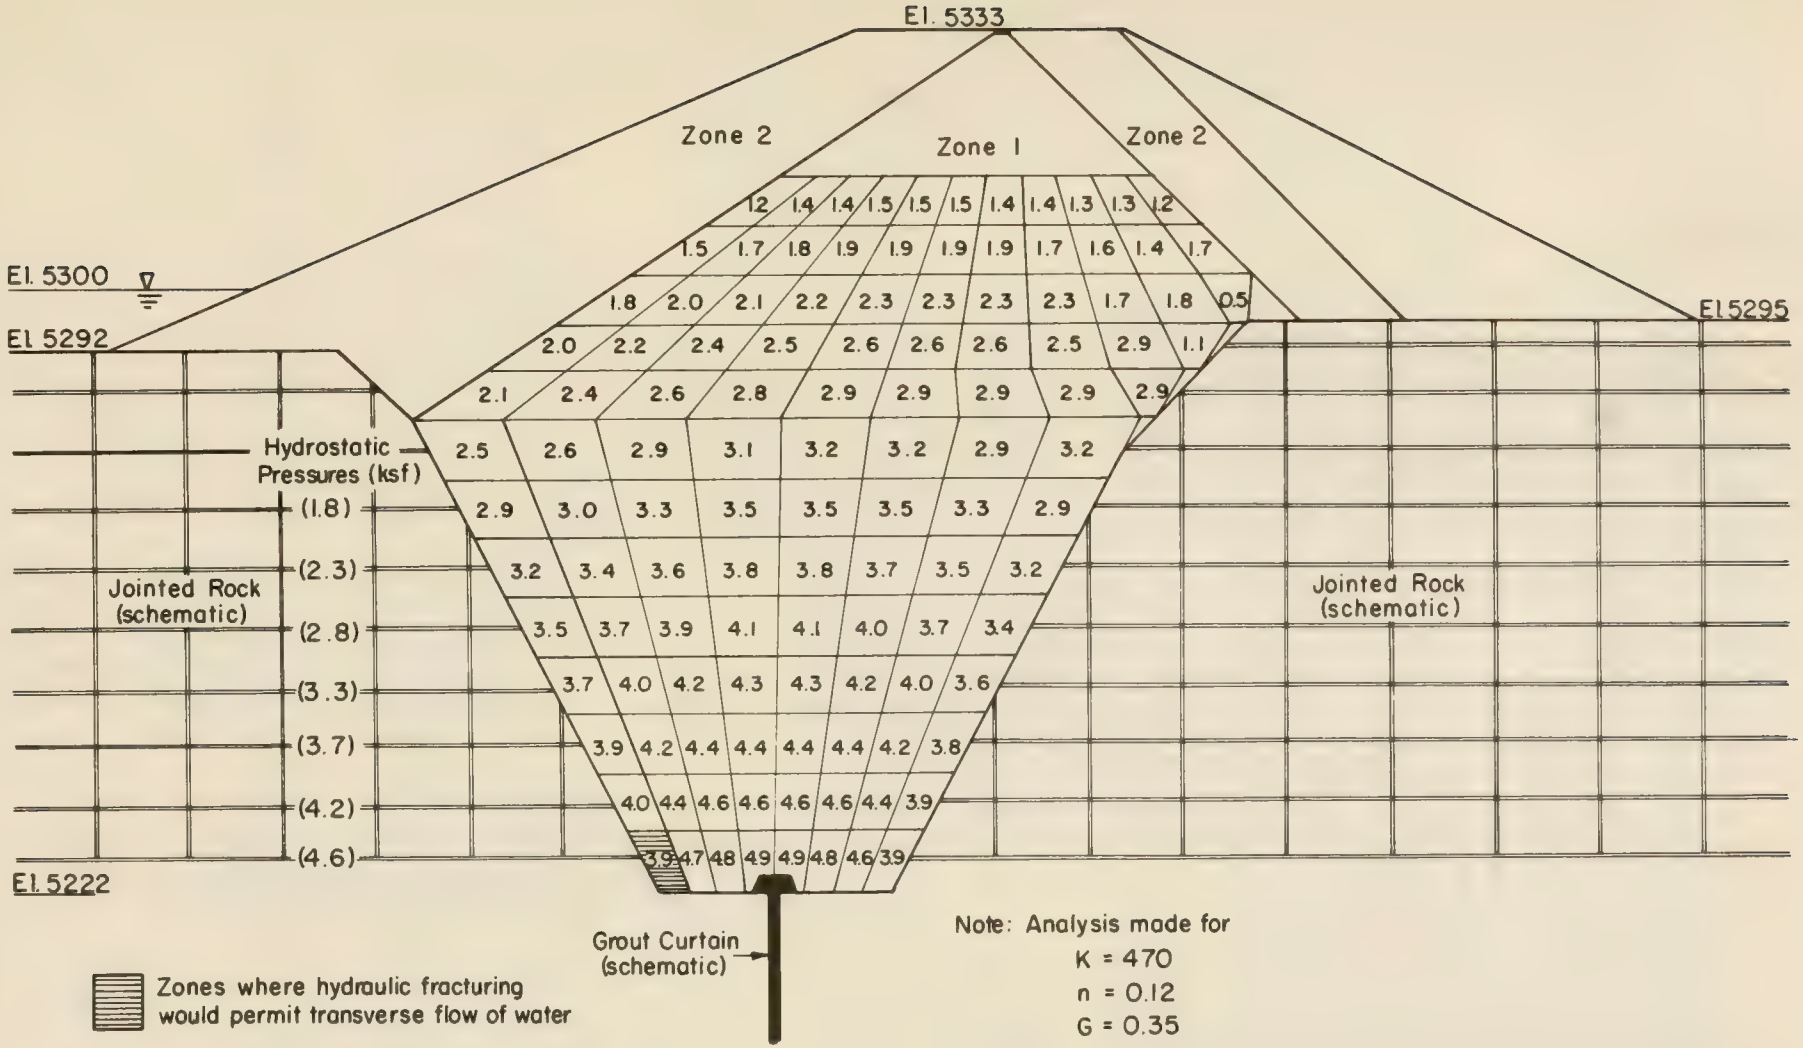
FIG. 11 COMPUTED VALUES OF NORMAL STRESS ON TRANSVERSE SECTION ksf STA. 12+70

upstream face of the key-trench fill. It is evident, however, that the calculated potential for hydraulic fracturing depends greatly on the actual water pressure. Since the efficiency of single-line grout curtains in rock, when determined by piezometric observations upstream and downstream of the curtains, has in reality turned out to be remarkably low, the actual water pressures are established by the conditions of flow through the foundation and curtain, and may be substantially less than full reservoir pressure. Therefore, the susceptibility to hydraulic fracturing determined by the foregoing calculations represents an upper limit.
